TECHNICAL BULLETIN TB-2022-11-01 Revision A

Re: CS200 Liquid Level Controller Firmware Update

Firmware update on the CS200

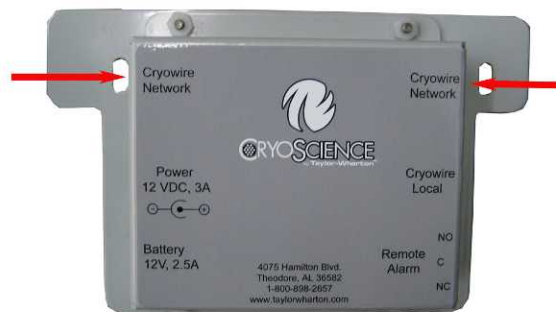
1. Plug the white Ethernet cable into one of the ports on the connector panel that is labeled "Cryowire Network". (Indicated with red arrows in the picture below). This is located on the back and is accessible through the connector box.

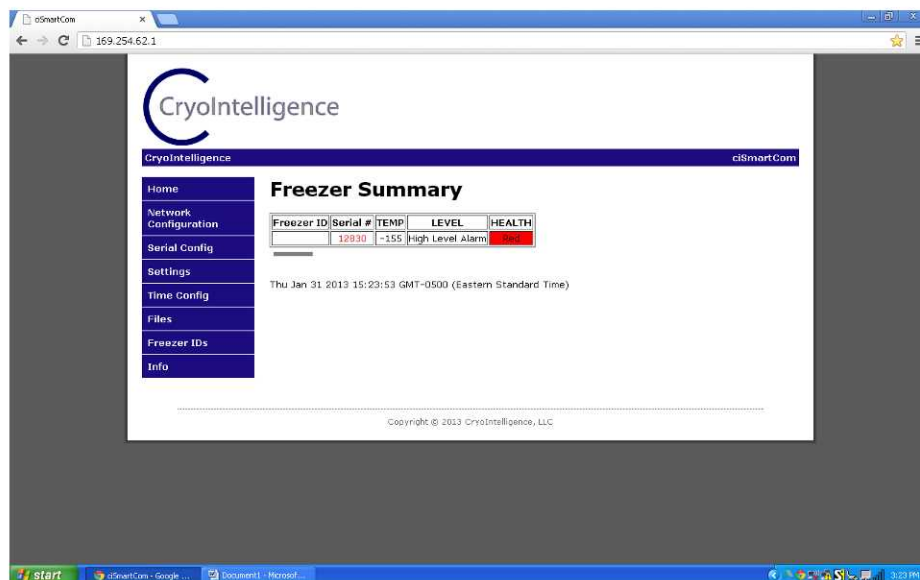
5. Connect the power supply into the ciSmart Com Hub.
6. Open a browser on the computer. It should be Chrome, Explorer 9 (or later), Firefox or Safari.
7. In the address bar enter the following: 169.254.62.1. The following screen will be displayed. The ciSmart Com hub will recognize the attached control and the control serial number will be displayed. It may take the computer and the ciSmart Com Hub a few minutes to establish a connection. If the computer and ciSmart Com do not connect, use the Discoverer utility to find the ciSmart Com hub. This utility can be downloaded at <http://cryointelligence.com/download.html>. (JAVA must be loaded on the laptop for the utility to run). Also, please note that the wireless transmitter may need to be turned off in the laptop so the utility will work through the hard wired port on the laptop.

- The screenshot shows the CryoIntelligence web application. The header is dark blue with the logo and navigation links. The sidebar on the left has a menu with 'Files' selected. The main content area features a table of files with the following data:

Below the table, there are sections for 'Delete Files', 'Upload File', and a copyright notice: 'Copyright © 2013 CryoIntelligence, LLC'.

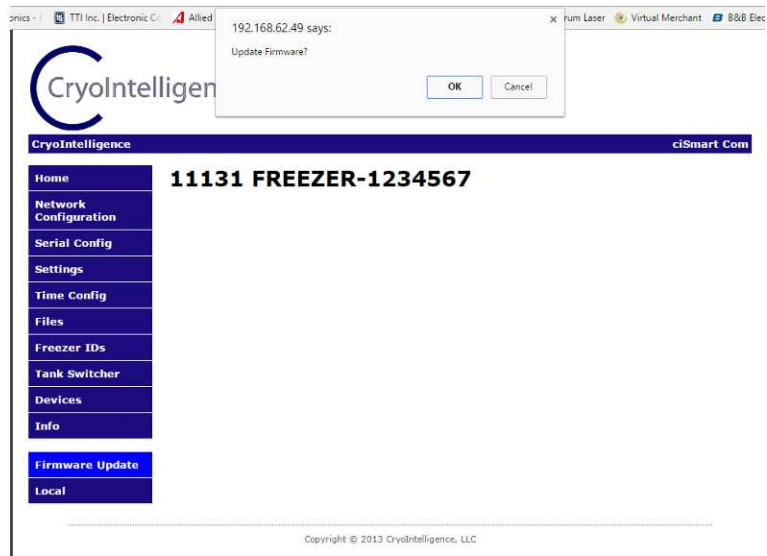
16. Point the mouse at the Menu choice “Firmware Update” and press the left mouse button. The following screen will be displayed.

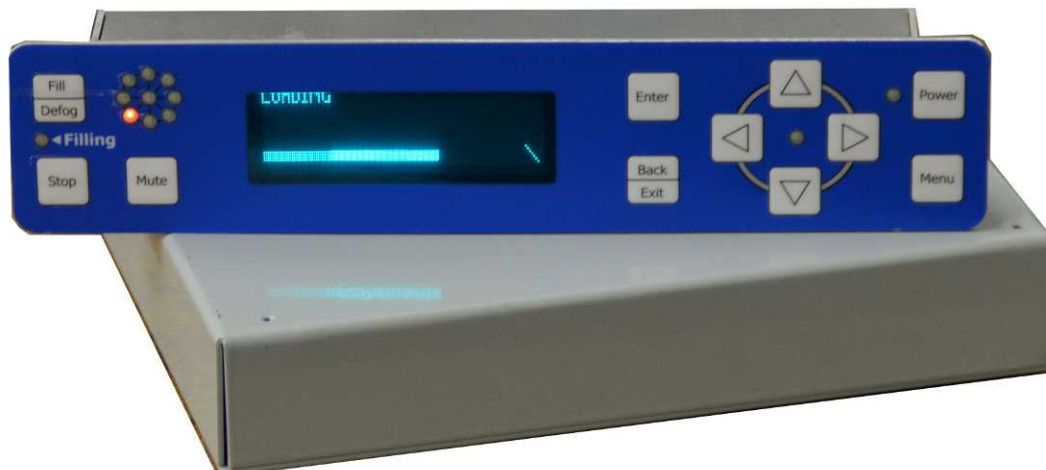
18. The ciSmart Com Hub will load the new firmware onto the control and then install it. While this occurs, the display on the control will show “LOADING” in the upper left corner of the display. A bar graph will show the progression on the lower line from left to right and a spinning baton will be displayed on the lower right side of the display.

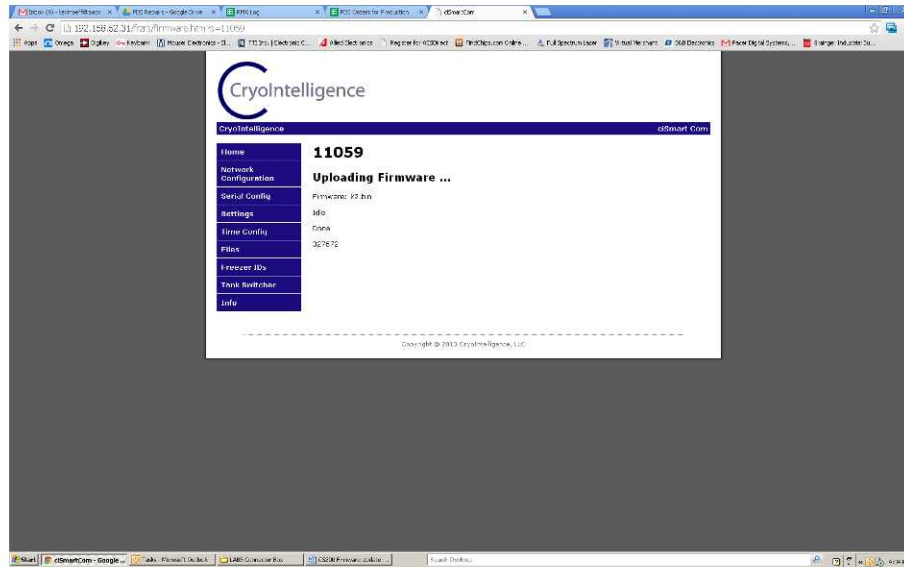
While the firmware is updated the following will be displayed on the computer. A timer will show the progression of the update as it occurs.

19. After receiving the message above, reboot the control by removing all power from the control (both AC power and battery power) and restoring it after waiting for 30 seconds.
20. After the control reboots, check valve operation by pressing the FILL button to open the valve and then pressing the STOP button to close the valve.
21. On the control, press the MENU button, scroll down to SYSTEM INFORMATION and press ENTER. Note the firmware version. It should match the firmware version information that was supplied with the update file. The firmware has been updated. The Ethernet cables and ciSmart Com Hub can be disconnected.

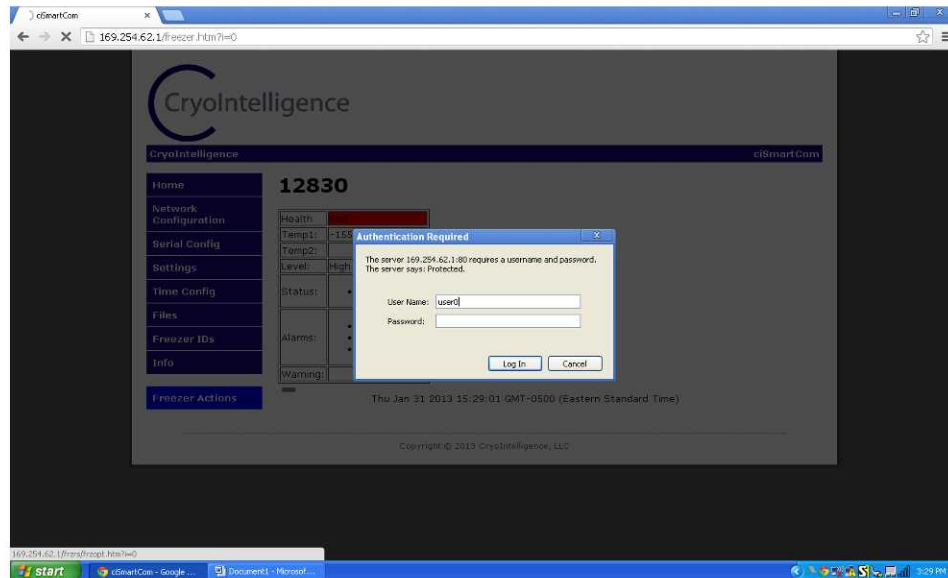
1. Enter URL 169.254.62.1 in your browser
2. If after waiting a few minutes no controls are listed, then very likely you have IE7.
3. Enter URL 169.254.62.1/frzrs/frzopt.htm?i=0 in your browser

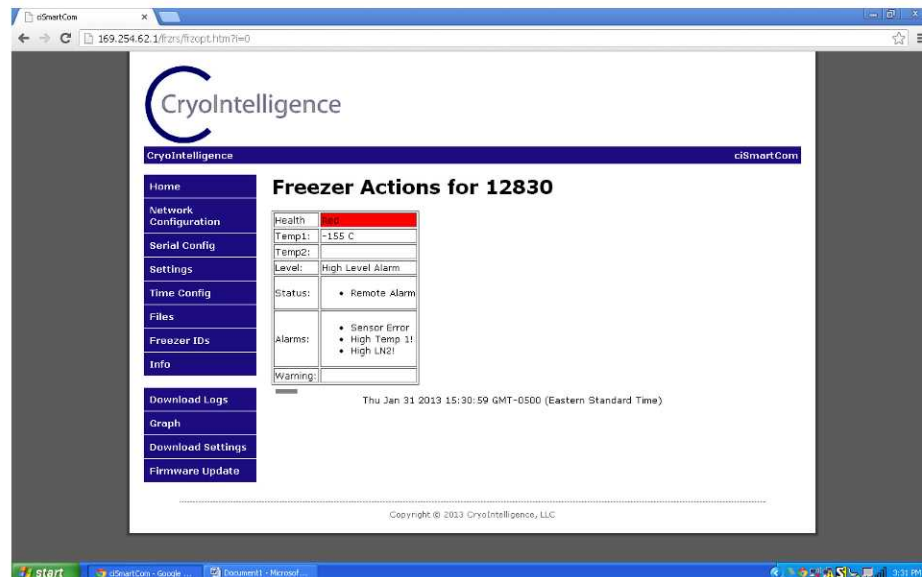
4. For the user name, enter user0. Leave the password empty, point at the Log In button and press the left mouse button. The following screen will now be displayed.

5. You should see a web page title Freezer Actions for <control serial number>. The serial number should match the control you are upgrading

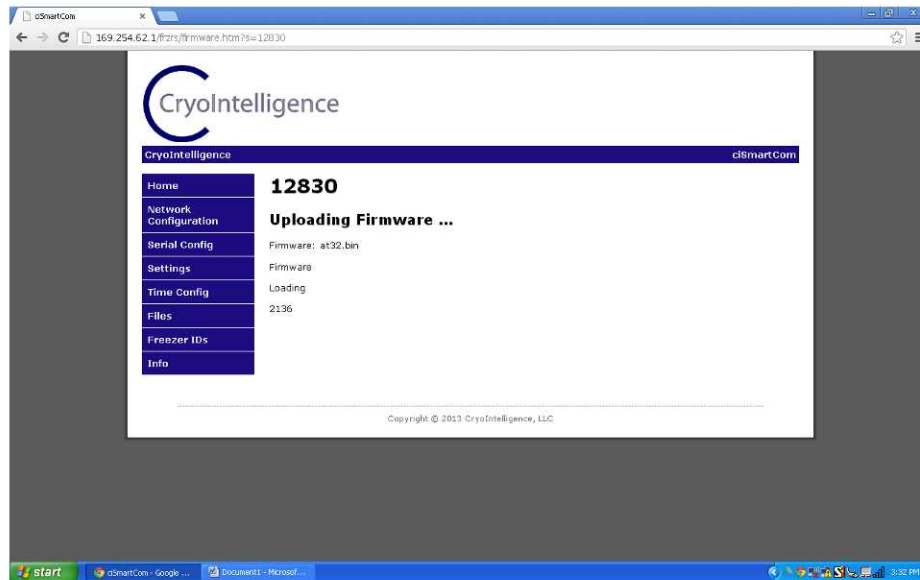
6. Enter URL 169.254.62.1/frzrs/firmware.htm?file=bin&i=0. You will see a firmware upgrade page.

7. It will take a few minutes and the counter will begin to count.
8. The ciSmart Com Hub will load the new firmware onto the control and then install it. While this occurs, the display on the control will show "LOADING" in the upper left corner of the display. A bar graph will show the progression on the lower line from left to right and a spinning baton will be displayed on the lower right side of the display. After the firmware is updated the following will be displayed on the computer. After a few minutes the control will reboot.

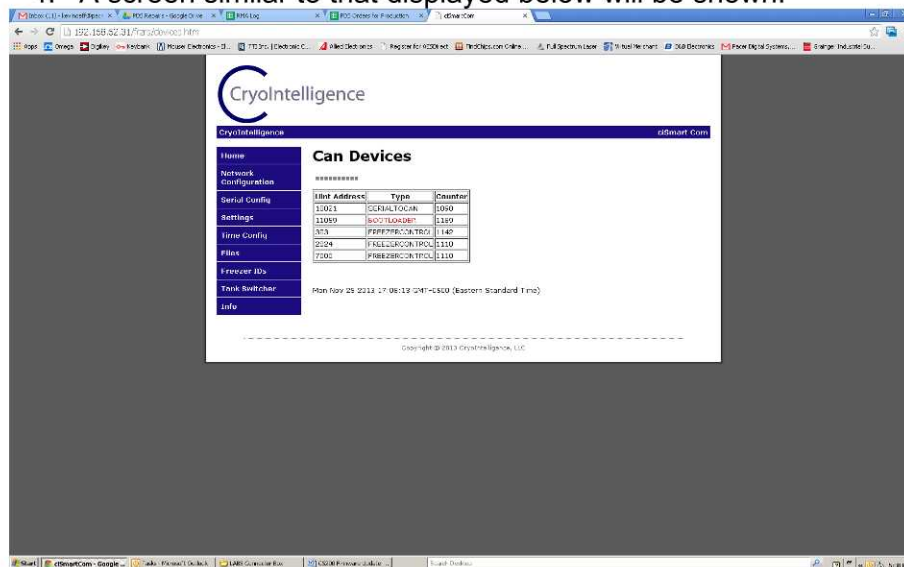
3. In the browser address line type in: 169.254.62.1/frzrs/devices.htm
4. A screen similar to that displayed below will be shown.
